GLOBAL JOURNAL OF ENGINEERING SCIENCE AND RESEARCHES
EFFECT OF CORROSION ON PERFORMANCE OF RCC BEAMS

Aniket Katkar¹, Ram Agrawal², Rushikesh Magar³, Utkarsha Tayade⁴ & Dr. S.S. Pusadkar^{*5}
^{1,2,3&4} B.Tech Final Year Students, Government College of Engineering, Jalgaon
^{*5}Professor & HoD Civil Engineering, Government College of Engineering, Jalgaon

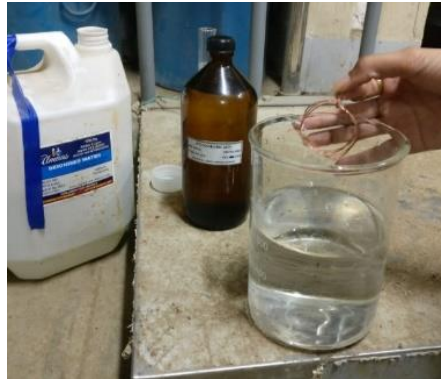
Figure 2: Preparation of Solution for Accelerated Corrosion

- Hydrochloric acid was measured 150 ml for 10 of water in a glass container.
- A short length of copper wire was wrapped into a coil and submerged it in the acid as shown in Fig. 2 for about a week. This dissolving copper into the acid solution creates a wash that will speed the rusting process.
- Copper was kept to soak by keeping cap loose. The gases produced during the chemical reaction caused pressure to build inside the bottle
- The copper was then removed from the solution using hand gloves and was discarded after some of copper dissolved in the solution. The solution was hence kept undisturbed for 7 days.
- Then the bars were washed with water to clean them from dust and rust was then kept submerged in the solution.
- Bars were then kept for 1 day for corrosion. The corroded bars after one day are shown in Fig. 3.

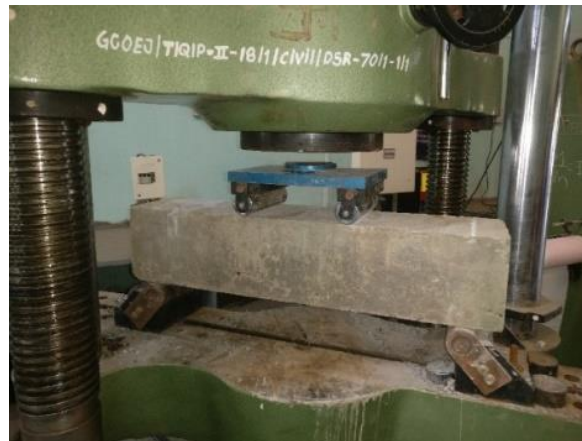
Figure 6: Set Up for Flexure Test

The specimen was placed in in the testing machine as shown in Fig. 6. The axis of the specimen was carefully aligned with the axis of the loading device and beam was placed without packing between the bearing surfaces of the specimen and the rollers. The load was applied gradually on beams and increased until the specimen failed, and the maximum load applied to the specimen during the test was recorded. The appearance of the fractured faces of concrete and any unusual features in the type of failure was noted.

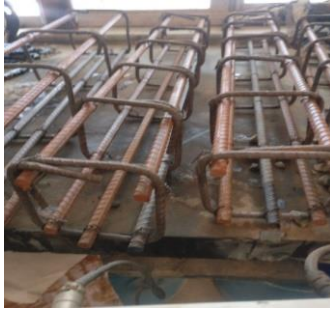
Figure 4: Reinforcement Work

The flexure test specimens of concrete were casted in the laboratory. Total fourteen RCC beams were casted of size 150 x 150 x 700 mm as shown in Fig. 4 and Fig. 5. Six beams were casted in standard sized mould with 4 no. and 3 no. of main reinforcement bars respectively (corroded and non-corroded) with different combinations as shown in Table 1 and Table 2.

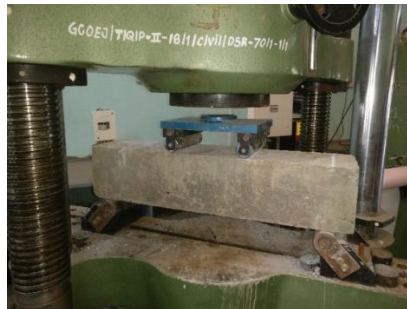
Figure 6: Set Up for Flexure Test

The specimen was placed in in the testing machine as shown in Fig. 6. The axis of the specimen was carefully aligned with the axis of the loading device and beam was placed without packing between the bearing surfaces of the specimen and the rollers. The load was applied gradually on beams and increased until the specimen failed, and the maximum load applied to the specimen during the test was recorded. The appearance of the fractured faces of concrete and any unusual features in the type of failure was noted.

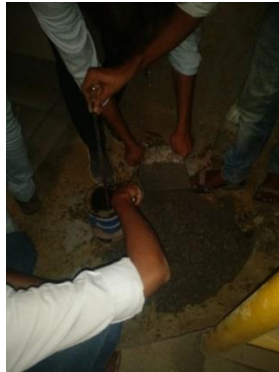
Figure 7: Casting of Cylinders

The bond strength is the measure of the effectiveness of the grip between concrete and steel and has no standard quantitative definition. Three concrete cylinders of 100 mm diameter and 200 mm height were casted and a 10 mm diameter steel rod was placed at the center of cylinder while casting as shown in Fig. 7. The specimens were removed from the moulds after 24 hours as shown in Fig. 8 and were put in water. Pull out test was performed after 28 days of curing. The bond failure was recorded in terms of load.

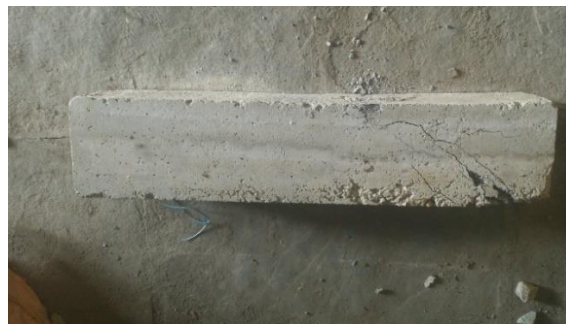
The average compressive strength of cubes was obtained as 21.4 N/mm² and this value is satisfactory for M20 grade. Fig. 11 and Fig 12 shows crack propagated at distance of 17.2 and 17.1 cm on tension side for beam no. 2 and 10 respectively. The test results of flexure test are given in Table 4.

Figure 11: Cracks in Beam no. 2 after Testing

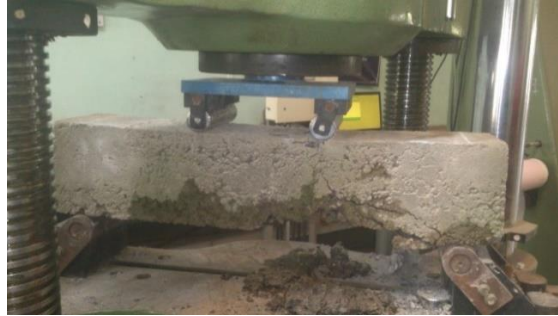
Figure 12: Cracks in Beam no. 10 after Testing

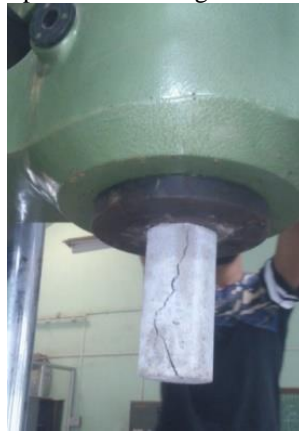
Figure 13: Pull Out Test Setup

Testing on the cylinder specimens for pull out test were conducted as shown in Fig. 13 and the specimen after testing is shown in Fig. 14. The test results of pull out test are given in Table 5.

Sr. no.	Specimen Type	Failure LoadKN	Bond StressMPa
1	Non-corroded bar	35.5	5.65
2	Corroded bar	35	5.57
3	Non-corroded bar coated with synthetic resin	30.3	4.82

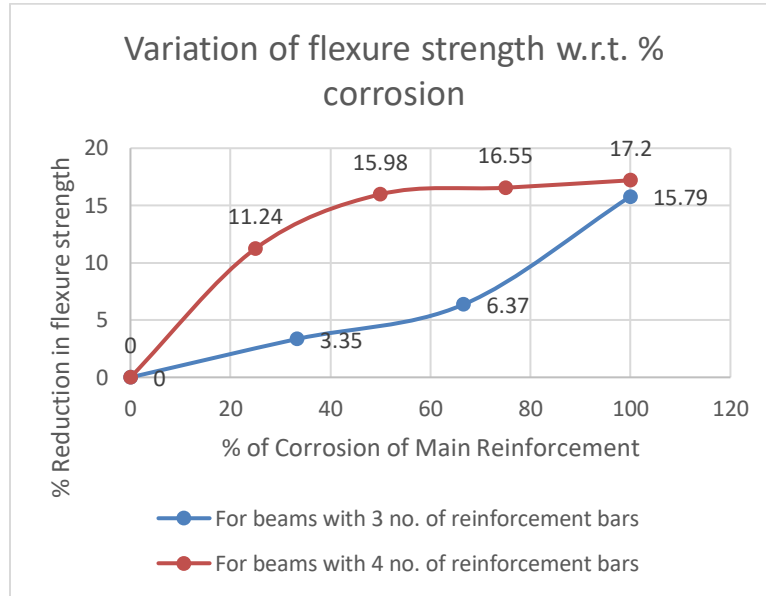
The variation of flexure strength of beams with 3 and 4 no. of reinforcement bars with respect to corrosion percentage is shown in Fig. 15.

Figure 15: Graph of Percentage Corrosion vs %Reduction

As the percentage of corrosion of main reinforcement bars increases the reduction in flexural strength increase. It can also be seen that for beams with 3 reinforcement bars, the rate of decrease in percentage of flexural strength is less than with 4 reinforcement bars. Maximum reduction in flexure strength was observed as 15.79% and 17.2% for beams with 3 and 4 no. of main reinforcement with all bars corroded.

- As the percentage of corroded main reinforcement bars increases the flexure strength of the beam specimen reduces.
- The maximum and minimum reduction of strength for 1.047% of main steel are 15.79% and 3.35% respectively, and for 1.396% of main steel the values are 17.2% and 11.24% respectively.
